# Brian E. Flynn, PE, PC

Letter #4770

Re: 32-49 37 Street, Queens  
Structural Stability

An inspection was made of 32-49 37 Street on November 6, 2009. The purpose of the inspection was to evaluate the exterior facade of the building for structural stability.

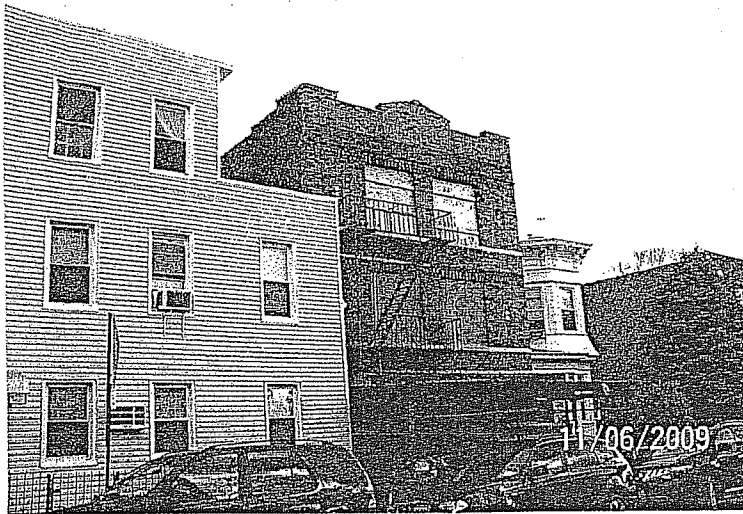
The left facade is on the property line and abuts the adjacent house. At the parapet level, some of the previous smear pointing has worn away and requires repointing. The wall is straight and there is no bulging or leaning noted. The left facade is secure to the front facade with no significant cracking at the joint.

32-49 37 St, Queens  
Left side bearing wall is not bowing or leaning

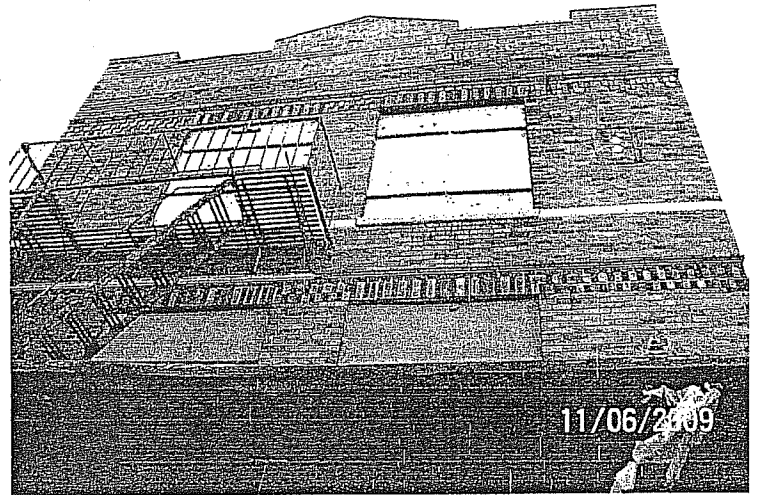
The front face has experienced some rust heave from the third floor right side window. This has created cracks and does need repair. The parapet wall still stands vertical and is not leaning or bulging. The front fire escape is secure and not in danger of collapse.

32-49 37 St, Queens  
Front facade is not bowing or leaning.

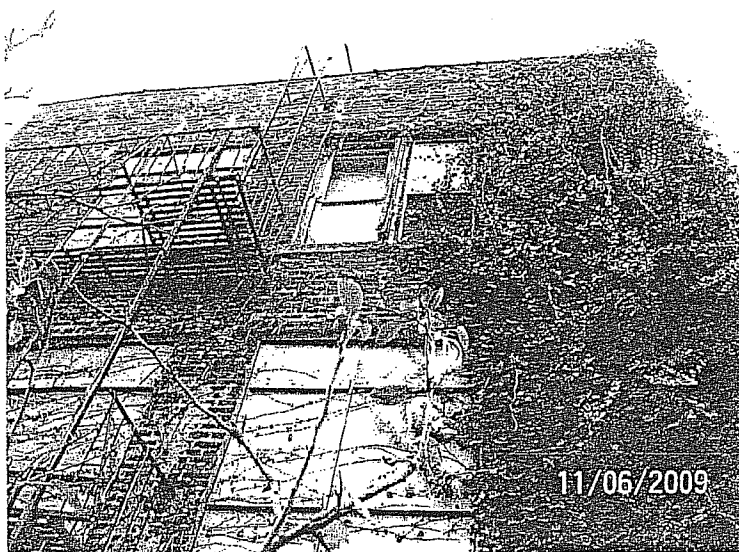
At the rear facade, some of the previous smear pointing has worn away and requires repointing. The wall is straight and there is no bulging or leaning noted. The rear facade is secure to the side facades with no significant cracking at the joint. The rear fire escape is secure and not in danger of collapse.

32-49 37 St, Queens  
Rear facade is not bowing or leaning.

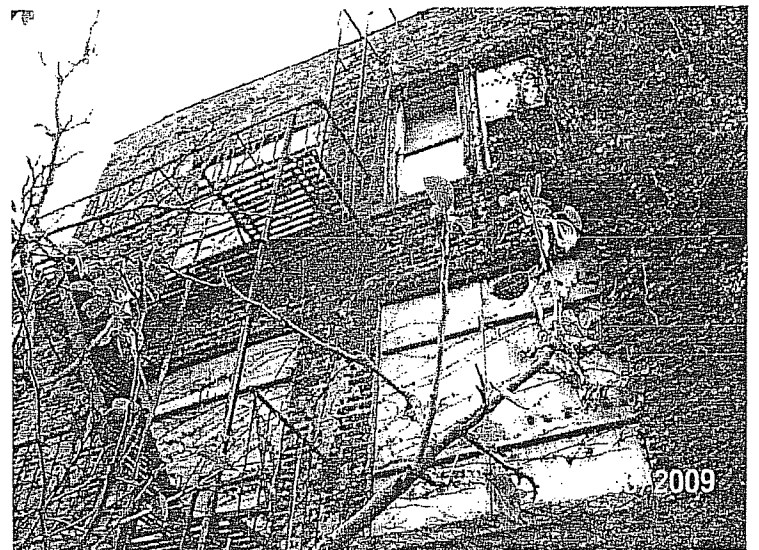
32-49 37 St, Queens  
Fire escape is not in danger of collapse

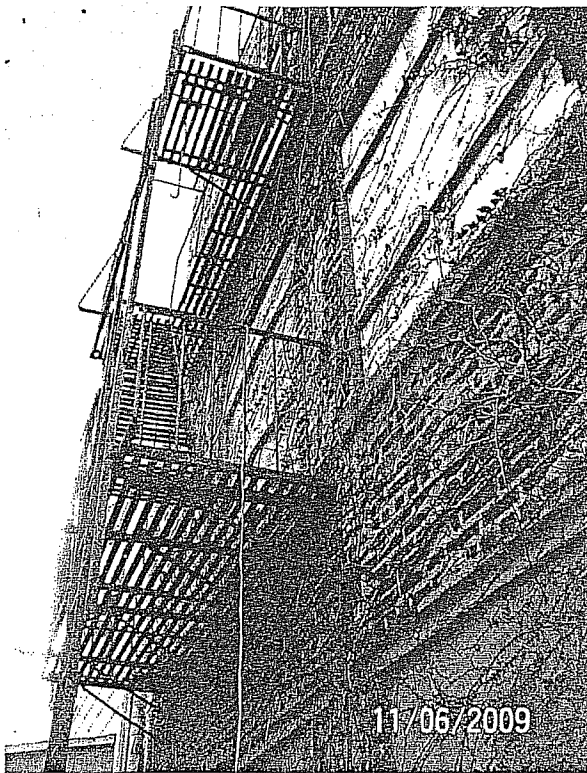
32-49 37 St, Queens  
Rear facade is not bowing or leaning. Fire escape  
is not in danger of collapse

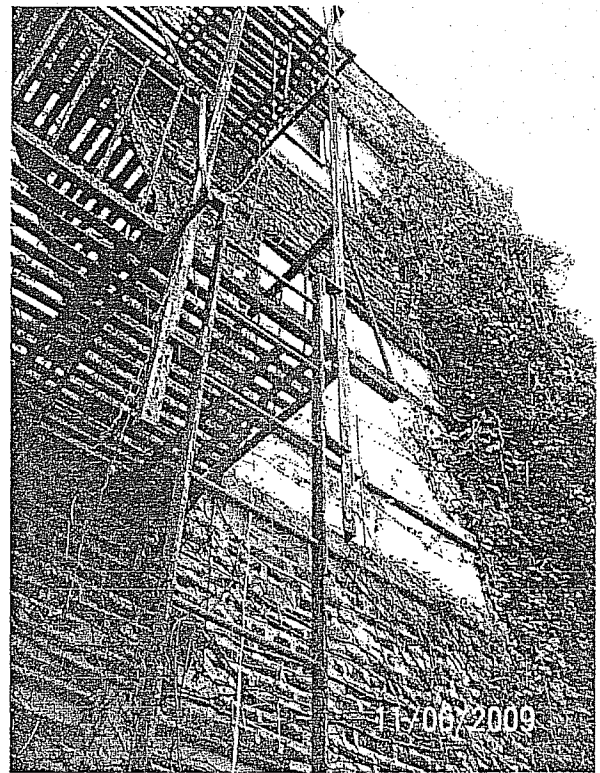
32-49 37 St, Queens  
Rear facade is not bowing or leaning. Fire escape  
is not in danger of collapse

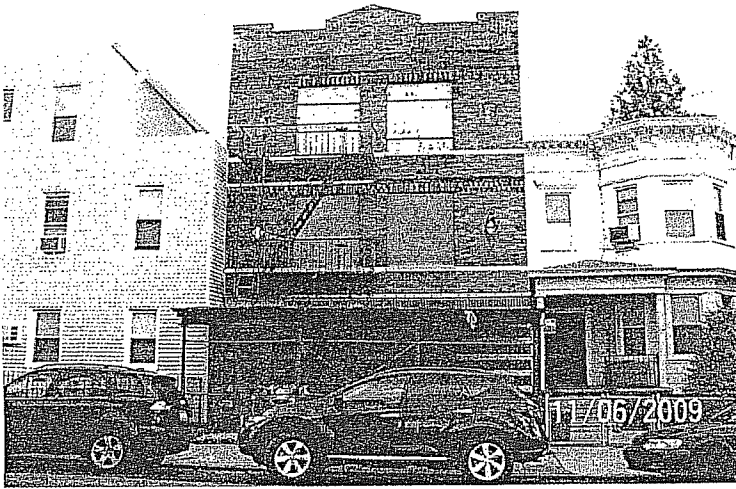
32-49 37 St, Queens  
Front facade is not bowing or leaning.

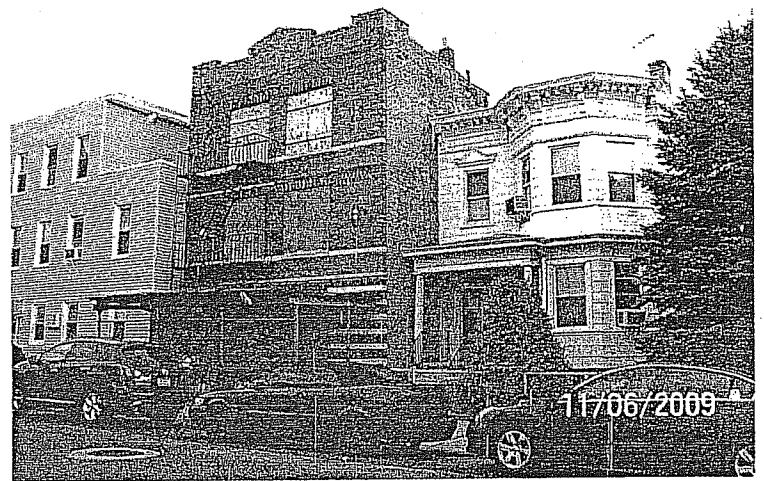
32-49 37 St, Queens  
Front facade is not bowing or leaning. Right side bearing wall is stable

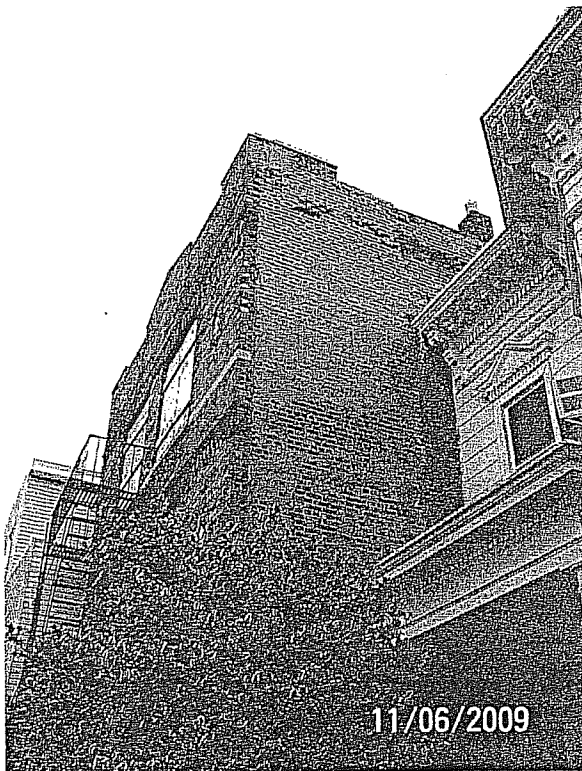
32-49 37 St, Queens  
Front facade is not bowing or leaning. Right side bearing wall is stable

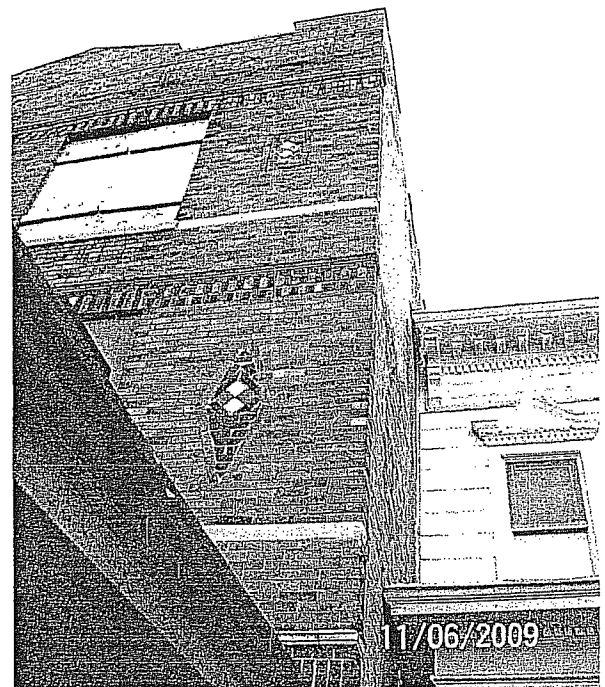
The right side facade is on the property line and abuts the adjacent house. At the parapet level, some of the previous smear pointing has worn away and requires repointing. There are two bricks missing as well. The wall is straight and there is no bulging or leaning noted. The front facade is secure to the side facade with no significant cracking at the joint.

32-49 37 St, Queens  
Right side bearing wall is not bowing or leaning
